SCP Tribune.®

Don't Forget to Look Up

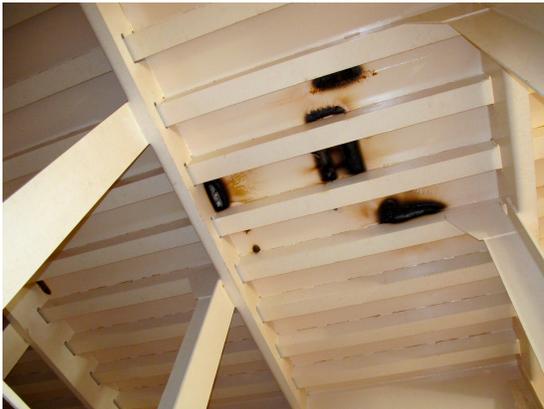
It's human nature. We automatically shine our bright flashlights at the deep spots of oil tanks and between the bottom longs in deck cargo barges. But recent fires should have us looking at the overhead, too.

Now we gaze upwards to make sure electrical insulation in wireways doesn't catch us by surprise. (*SCP Tribune*, July, 2013).

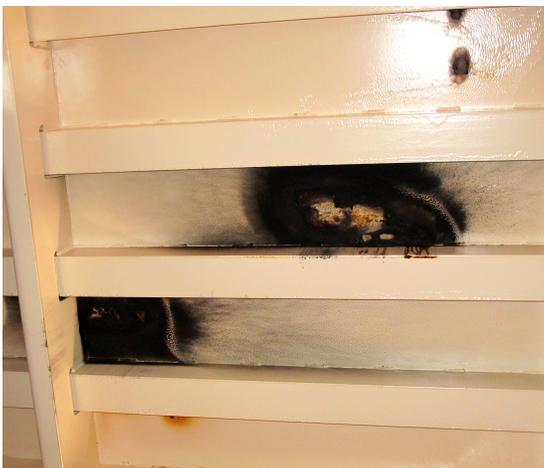
Thick paint can also get us in trouble. Check out these photographs of the overhead in a void: In the top photo, you can see the pattern where production welding charred the

paint. No problem, you might say. Discolored paint isn't something we worry about. But note the second image. The geometry isn't so sharp there, as the orange-peel-thick coating actually caught fire and fell away. Gobs of flaming paint dropping on laundry stowage may worry the Competent Person more than mere discoloration. At the very least we may run some more water lines to worksites, and use some more wet fiberglass blankets to shield burnable stuff in spaces that have been heavily painted.
